*Early Domestic Architecture  
of Connecticut*

*By J. Frederick Kelly*

J. Frederick Kelly, A.I.A.

New Haven: Yale University Press

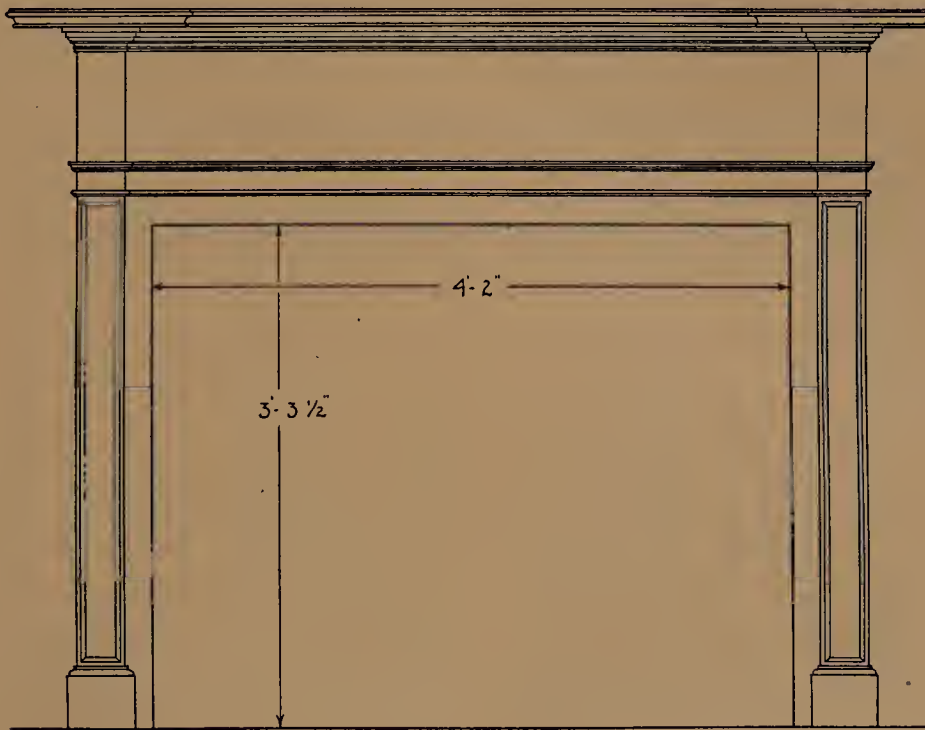
FIGURE 177.

✓ RUTH HART HOV ✓ L ✓ GUILFORD ✓

As may be seen from Figure 177, this type of mantelpiece, in its unelaborated form, consisted of two plain pilasters without entasis, usually of about 4 inches' width and  $\frac{7}{8}$  of an inch in thickness, placed on high plinth-like bases. The pilaster caps were formed by mitered continuations of the simple mouldings which made up the architrave, above which was placed a plain frieze. This was of considerable height, comparatively speaking: generally eight or nine inches. Vertical breaks, corresponding to the pilasters in width and projection, were carried up through it. About them were mitered the simple bed mouldings of the cornice; and the whole was surmounted by a thin shelf, of six or eight inches' depth, with moulded edges. In the simplest examples the breaks formed by the pilasters were not repeated in this shelf or top member. In more finished specimens the faces of the pilasters were panelled, and also provided with regular moulded bases and capitals along Classic lines. The breaks caused by the pilasters were also repeated in the shelf member, and the edge of the central portion was finished in a gently rounded arc. Such compositions were entirely Classical in feeling and spirit, and they were as strongly indicative of the influence of Wren and his school as was the exterior house cornice of later form.

From about that time onward, and especially during the first quarter of the nineteenth century, when it reached its fullest development, this type of mantel, with its typical pilaster arrangement, represented the conventional manner of fireplace treatment. It was repeatedly used in a vast variety of forms, each of which was but a development or variation of a fundamental scheme. The typical arrangement consisted of two pilasters, one on either side of the fireplace opening, supporting an architrave, frieze, and cornice, the top member of which, of exaggerated projection, served the purpose of a mantelshelf. A typical example of this scheme in its simplest form is shown in Figure 177.

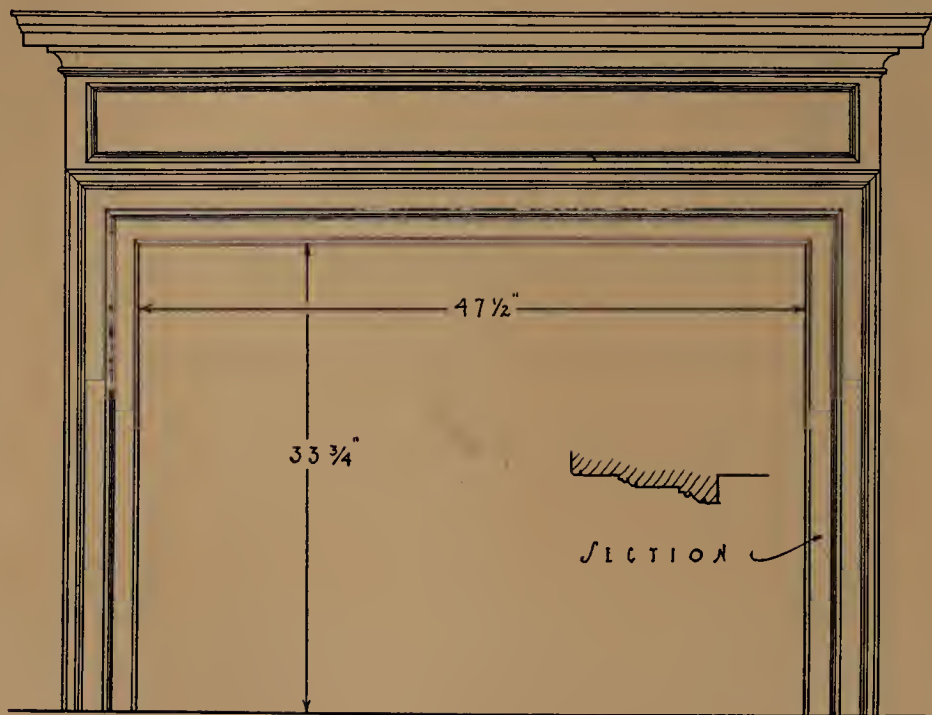
FIGURE 179.

✓ PRATT TAVERN - SAYBROOK ✓

As might naturally be expected, the most ornate and elaborately designed mantelpiece is, as a rule, to be found in the parlor. That in the hall or living room is usually less pretentious; and those in the chambers of the second floor are still simpler. Such chamber mantelpieces generally consist simply of a moulded architrave trim around the fireplace opening, with a plain or simply panelled frieze above, surmounted by a few plain mouldings and a shelf. An example of this arrangement is shown in Figure 179, though this particular specimen exists in a room on the first floor.

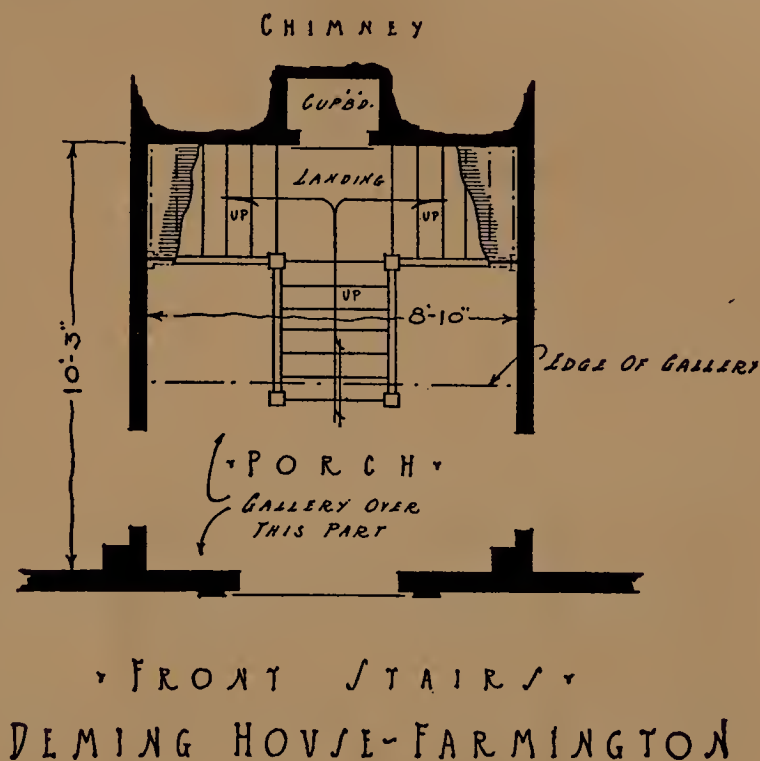
FIGURE 183.

A front stair arrangement which is comparatively rare and of great interest is that illustrated in Figure 183. The stairs are in the usual space—in front of the chimney stack—but instead of ascending in the usual fashion, they begin directly opposite the front entrance and branch right and left from a landing about halfway up. Doors directly at the

top of each flight communicate with the hall and parlor chambers respectively; and access from one room to the other is by means of a gallery above the porch at the second floor level.

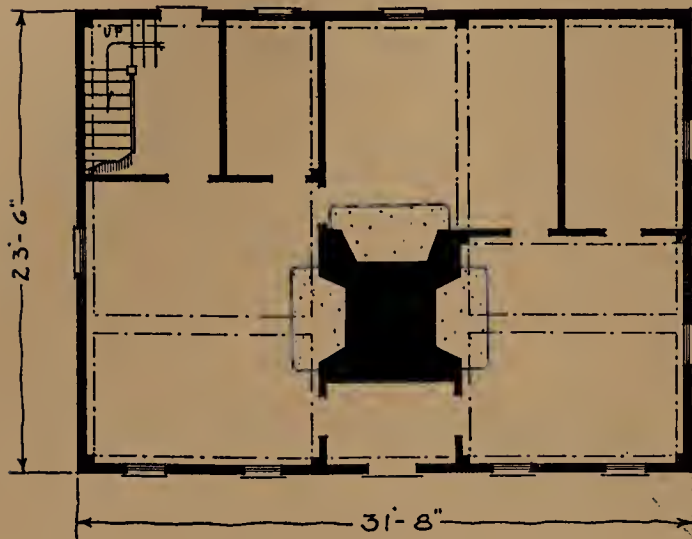
FIGURE 184.

▷ FIRST FLOOR PLAN ◁  
↙ BROCKWAY HOUSE - HAMBURG ↘

But the first-floor plan of the Brockway house near Hamburg (*circa* 1725) shows that the main staircase occupies a very unusual place—at the rear of the house. (Figure 184.) Yet it is not of the back-stairs type, but is carefully and somewhat elaborately built, with well-turned balusters and a moulded hand-rail. (Plate XLIII.) From first glancing at the plan of the Samuel Webster house (1787) in East Windsor Hill (Figure 185), it would seem that a similar arrangement existed there. But here the *only* stairs to the second floor are the back stairs, which are enclosed with pine wainscot and have no hand-rail. This is a brick house, only a story and a half in height.

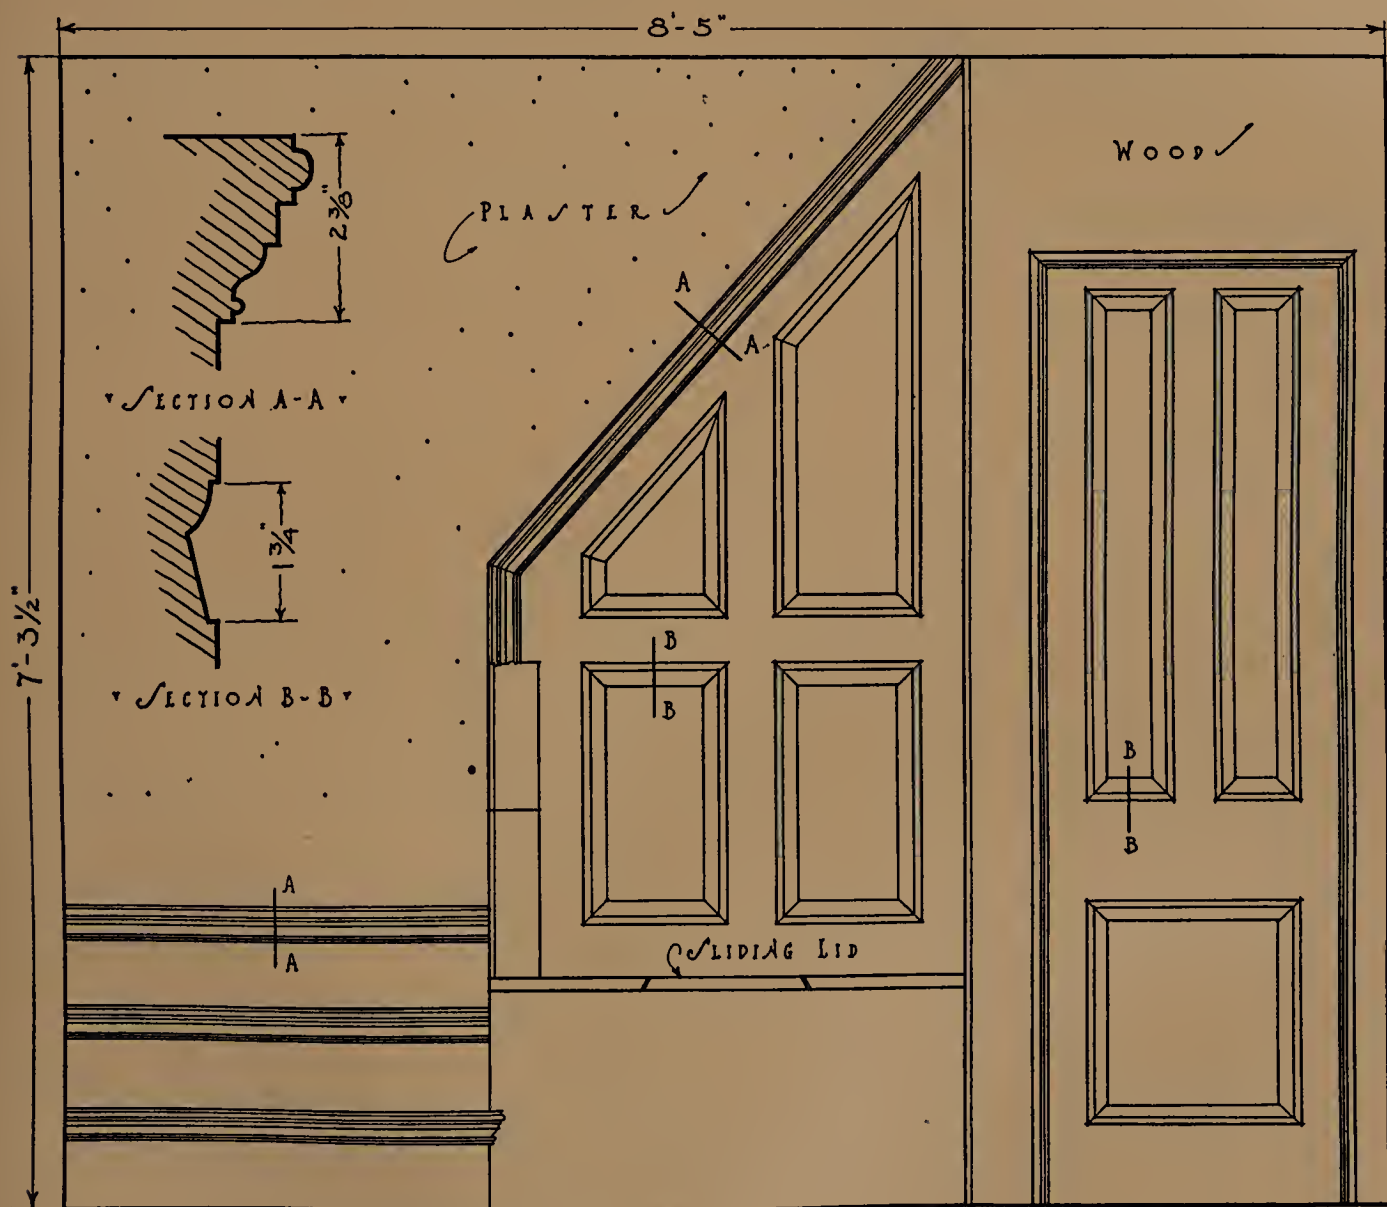
FIGURE 186.

✓ CAPT. LEE HOWE - GUILFORD ✓

running vertically. The front stairs in the older Bushnell house (1678-1679), near Saybrook, are of this arrangement. (Figure 3.) The use of panelled wainscot below the handrail partially to enclose the stairs is illustrated in Figure 186. Treatment of this sort is decidedly out of the common; the writer has not seen similar work elsewhere in Connecticut.

Another feature of interest which deserves mention in connection with the stairs of central-chimney houses is the small seat or bench usually built beneath them and against the panelled wainscot. (See Figure 186.) If we are to use the term "sparking-bench," commonly applied to this arrangement, we must needs accept the oft-repeated statement that it afforded the amorous swain, on his way to the door, a last tarrying place for fond farewells. Judging from their size, many such benches must have been a tight squeeze. Some of these sparking-benches, but not many, have hinged lids. That in the Captain Lee house in Guilford (1763) has a section of the seat, thirteen inches wide, which slides out, thus giving access to the space beneath. (Figure 186.)

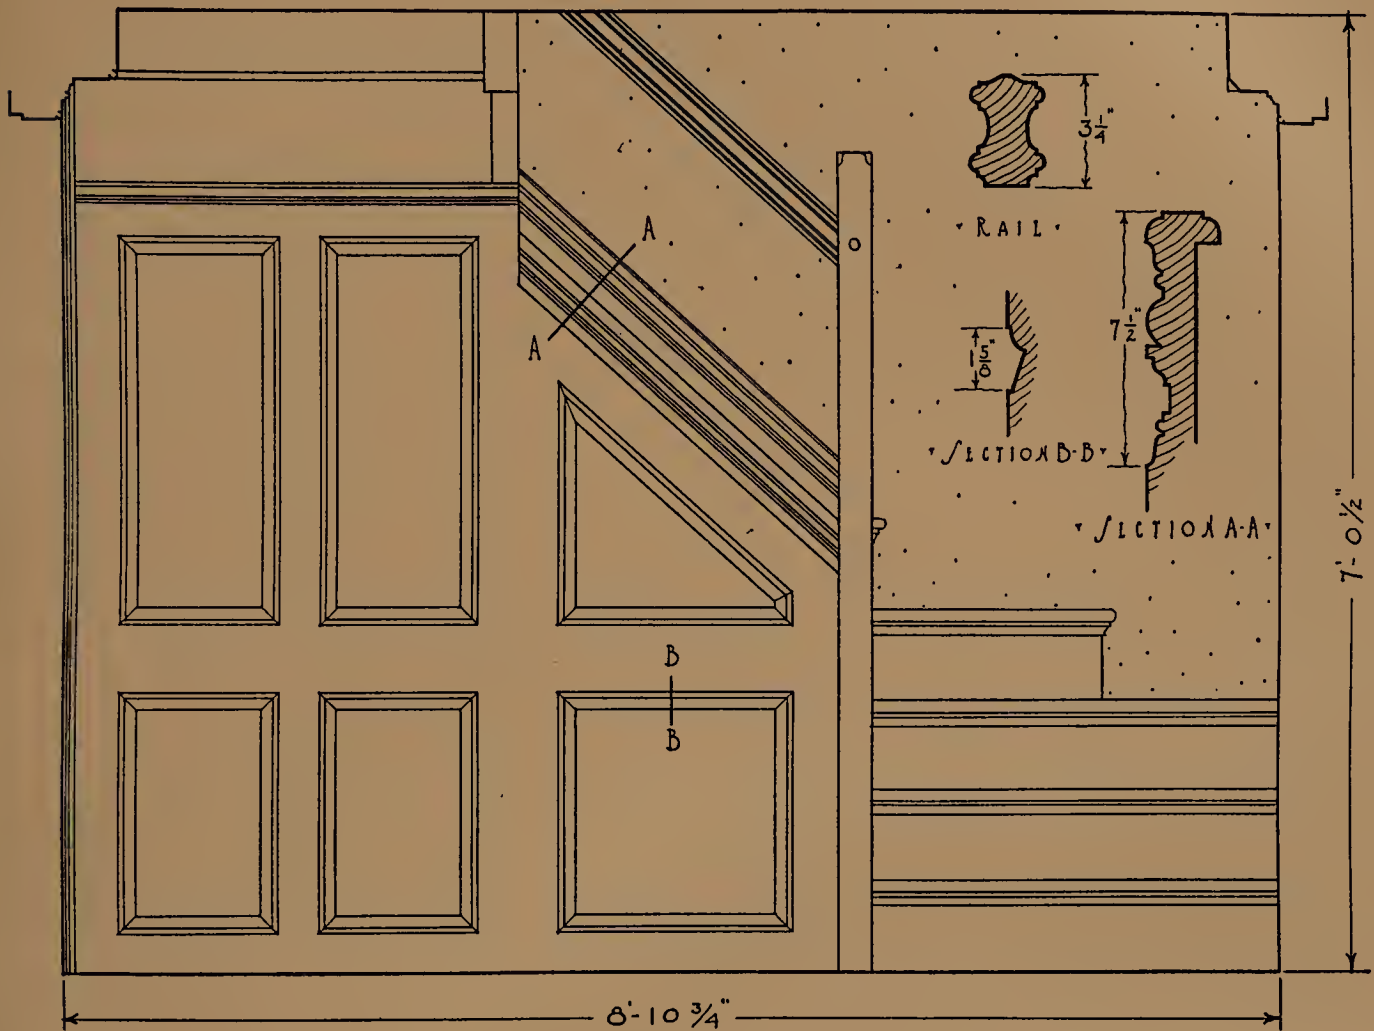
FIGURE 188.

MOULTHROP HOUSE - EAST HAVEN

The next development is the omission of the enclosing wainscot and the introduction of plain square newels and a rail. The open end of the stairs—*i.e.*, the part away from the chimney—was covered by a continuous or box string, in the treatment of which mouldings early came into use. (Figure 187.) The space below the string was covered with simple wainscot, and later came to be panelled. The front stairs of the Moulthrop house in East Haven, shown in Figure 188, are characteristic of this period.

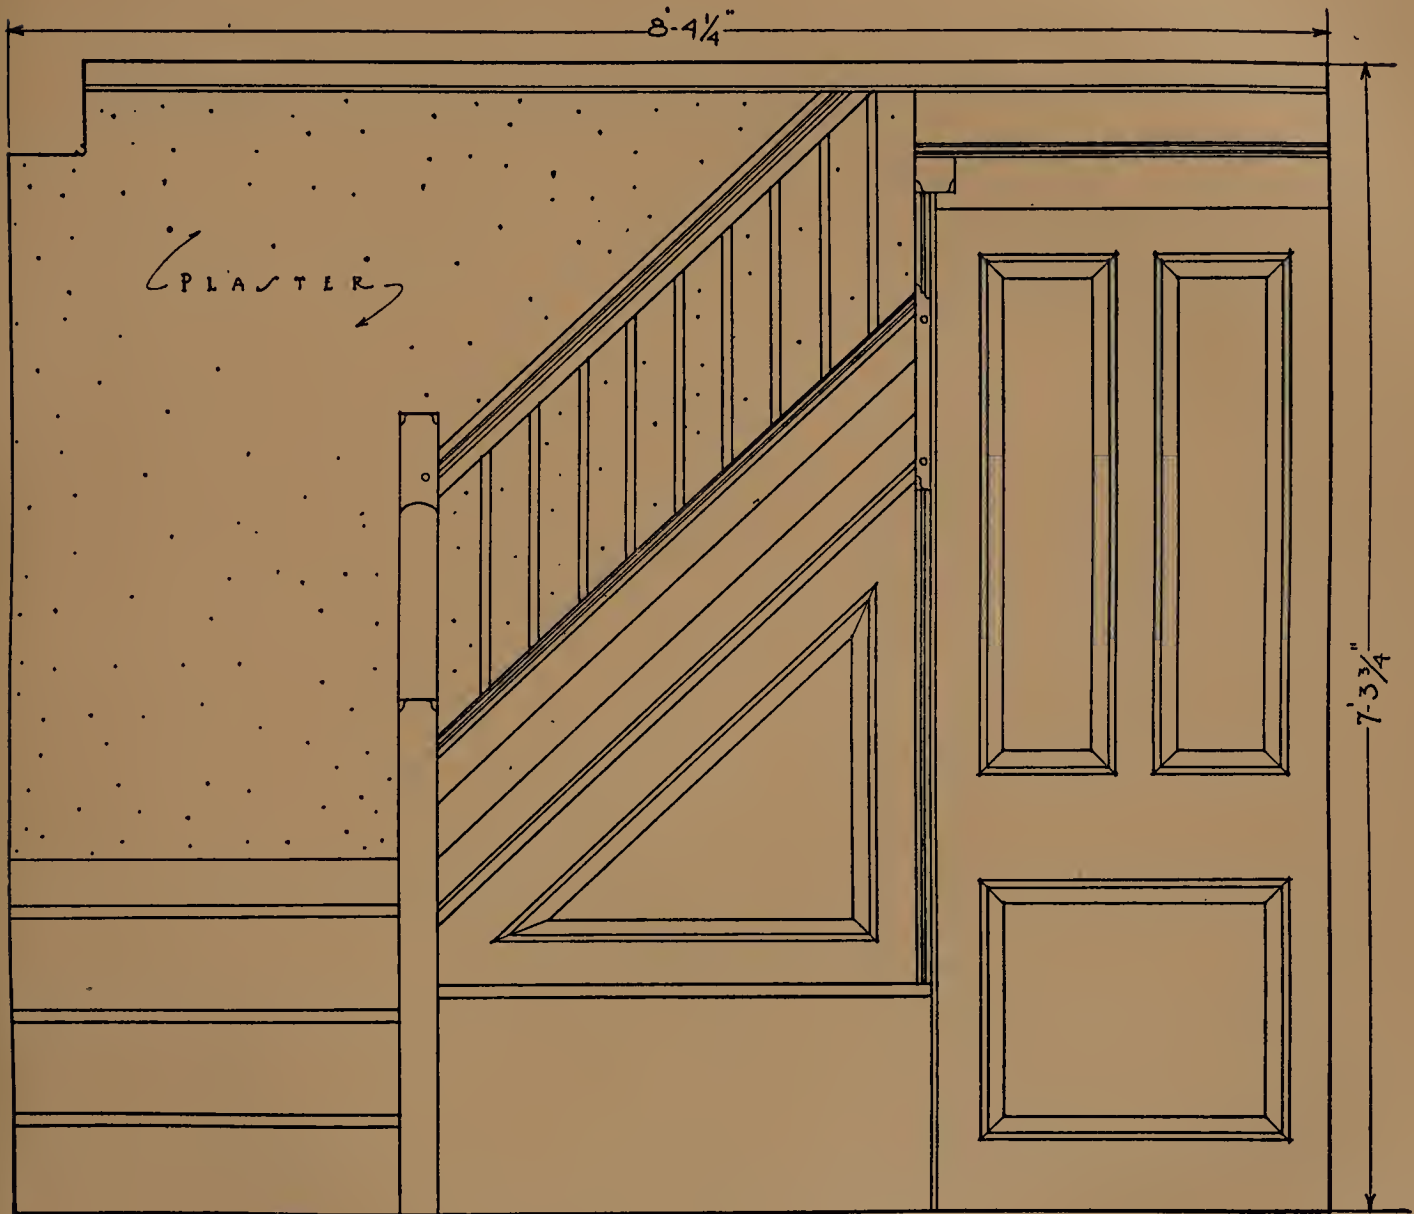
FIGURE 193.

GEORGE GRISWOLD HOUSE - GUILFORD

Flat balusters, with a contour on two edges produced by sawing, such as may be found in Rhode Island, are a rarity in Connecticut. They are not to be met with west of New London. Balusters of simple rectangular section are not common: it is evident that, even in very early days, the turned baluster was in high favor. A typical example of plain balusters may be seen in the front stairs of the Ezra Griswold house in Guilford (*circa* 1760), shown in Figure 193.

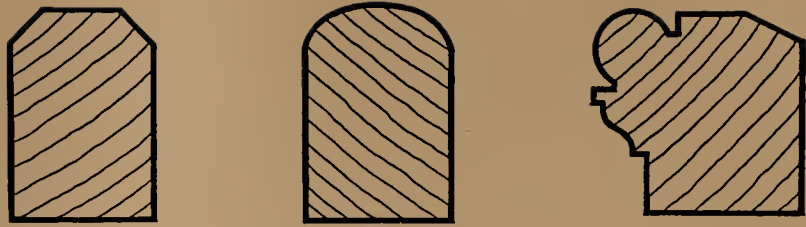
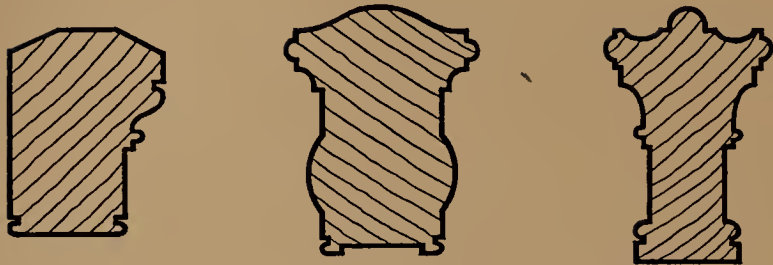
FIGURE 194.

• EARLY TYPES •

• LATER TYPES •

By comparing different specimens, the development of the hand-rail may be traced. The various examples group themselves into three general classes. (Figure 194.) The first type was of simple rectangular section, chamfered slightly at the corners or rounded on top. The next step was marked by the use of mouldings, usually on the outer side, away from the stairs, so that the rail is unsymmetrical in section. The third and ultimate stage is marked by the moulded rail of symmetrical type and greater elaboration. Hand-rails of this last sort are typical of the last period of stair construction in both central-chimney and central-

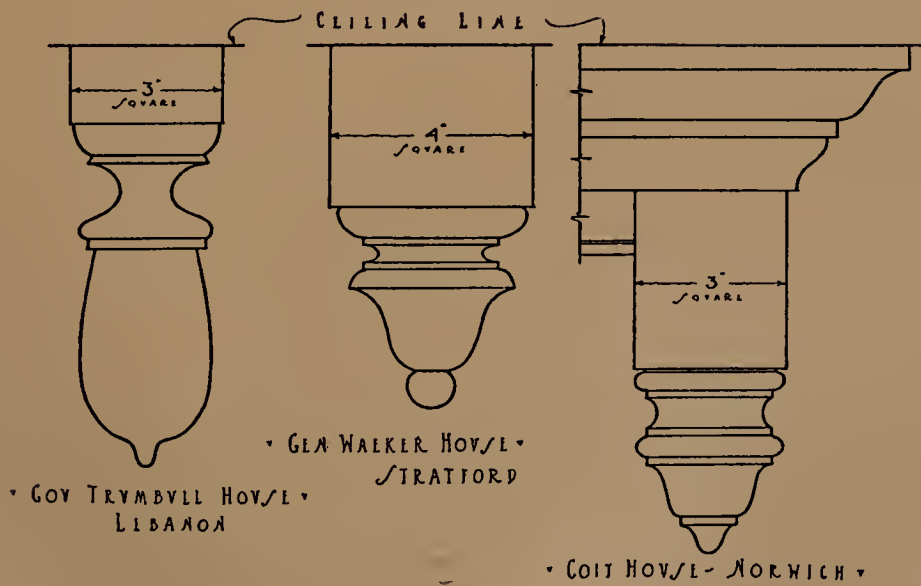
FIGURE 198.

GOV TRYMBULL HOUSE  
LIBANON

GEN WALKER HOUSE  
STRATFORD

Occasionally the lower end of the post at the top of the flight is to be found projecting below the finished ceiling of the porch. Where this occurs, the newel usually terminates in a series of handsomely turned mouldings, as does that in the General Walker house in Stratford (*circa* 1740), shown in Figure 198. The same treatment is to be seen in the Coit house in Norwich (1785) and the Governor Trumbull house in Lebanon (1740); but

these are of the central-hall type. The post in the last-named house is turned in the form of an acorn and its cup. (Figure 198.)

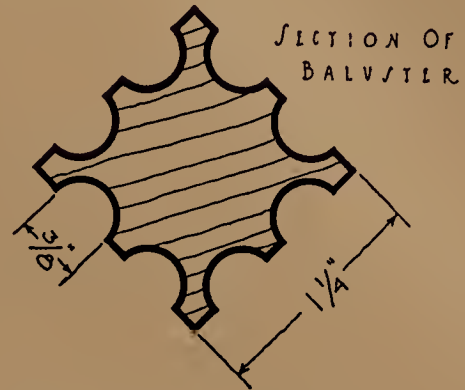
FIGURE 201.

DR. RICHARD NOYES HOUSE-LYME

An unusual treatment of the stairs may be seen in the Dr. Richard Noyes house in Lyme (1814). A half rail, with half balusters below it, has been applied to the plaster wall, repeating the rail and balusters of full section on the open side of the stairs. (Plate XLV.) The balusters of this staircase are quite uncommon in form. They are square in sec-

tion, set diagonally upon the treads, and each side is channelled with two vertical flutes. (Figure 201.) Balusters of a similar section were used in the Judge William Noyes house in the same town (1756).

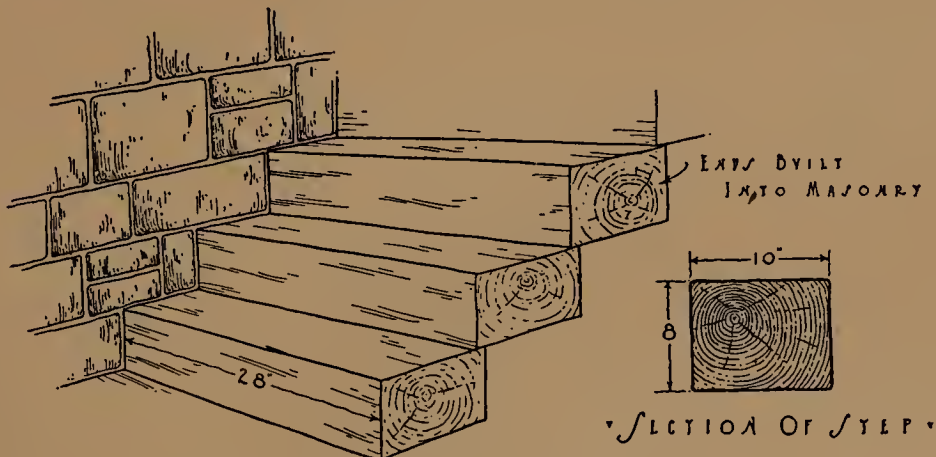
FIGURE 202.

CELLAR STAIRS

MOULTHROP HOUSE-LAST HAVEN

Cellar stairs of the earliest type, such as occur in front of the chimney stack in houses of two-room plan, were of either stone or solid oak logs. When made of logs of rectangular section, like those in the Moulthrop house in East Haven (*circa* 1690), they were generally

built into the masonry walls which enclosed them on either side. (Figure 202.) Some houses, such as the Thomas Lee house in East Lyme (1664) and the Beckley house near Berlin (*circa* 1685), have cellar stairs made of solid oak logs of triangular section, secured with wooden pins to heavy string pieces. (Figure 203.) Solid wooden steps are rare, and but few specimens remain to-day. Work of this sort has a distinctively English flavor.

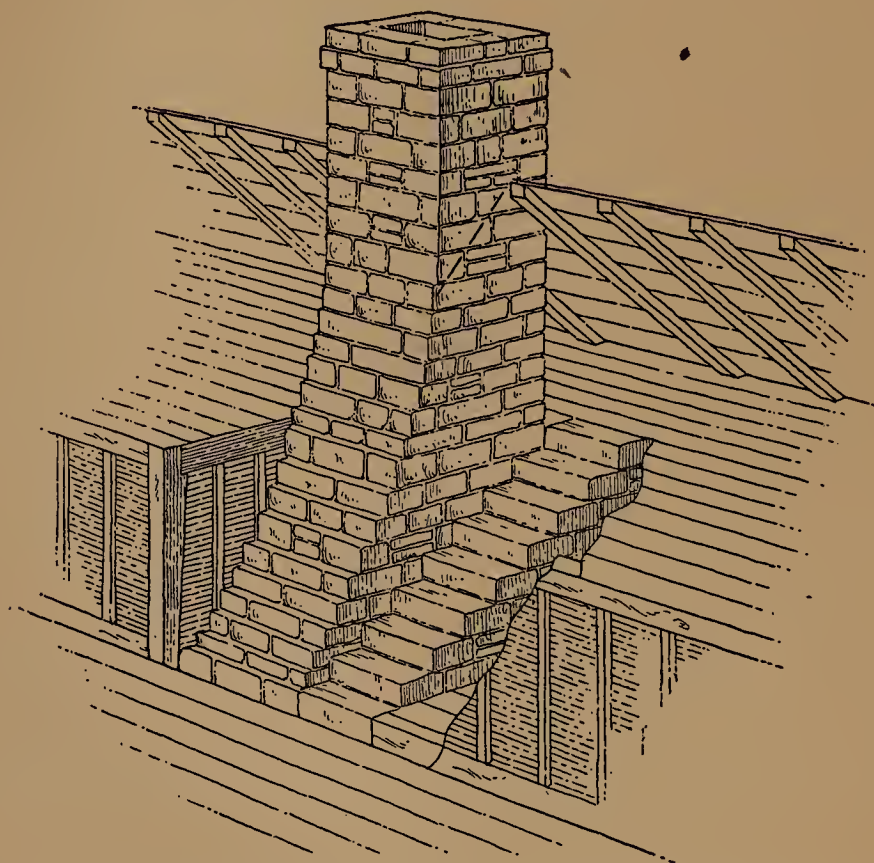
FIGURE 206.

♪ HAWLEY HOUSE - MONROE ♪

The attic stairs of the Cyrus Hawley house in Monroe (*circa* 1740) consist of a flight of stone steps built against one side of the central stone chimney and leading up from the

lean-to attic. (Figure 206.) The steps are very steep. Each is a single block of stone. The stones of the chimney stack are laid in clay, and the steps are bedded in the same material. A similar arrangement exists in the Buckingham house near Huntington (*circa* 1740), not far from Monroe; and such construction being most unusual, it is probable that both houses are the work of the same builder.

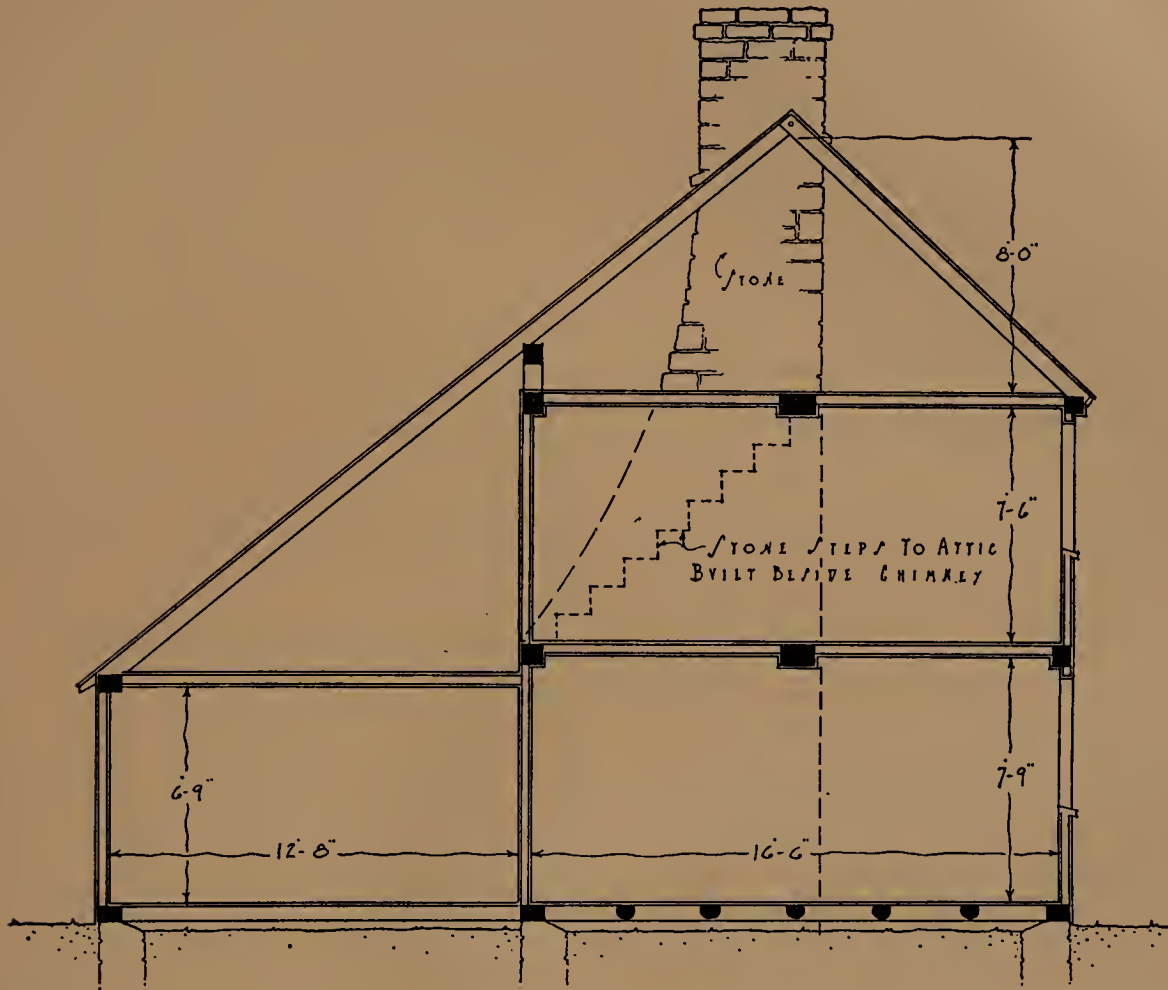
FIGURE 207.

~ CROSS SECTION ~  
 ~ HAWLEY HOUSE - MONROE ~

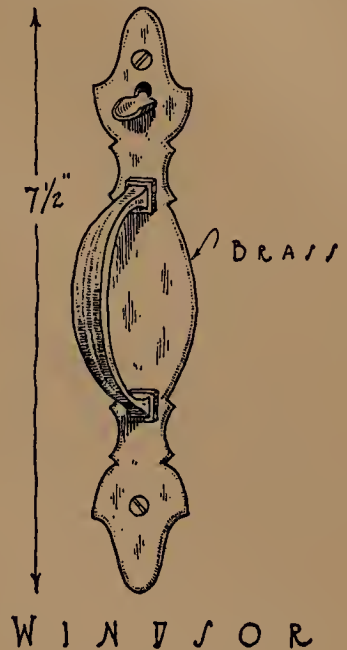
FIGURE 211.

Hinges, latch handles, bolts, and various other articles of hardware used in the early Connecticut house were, for the most part, forged from wrought iron. Occasionally latch handles of brass are to be found (Figure 211), but they are rare by comparison with those of iron. Door knockers, though, were generally of brass; and it is probable that a good many of them were of English manufacture.

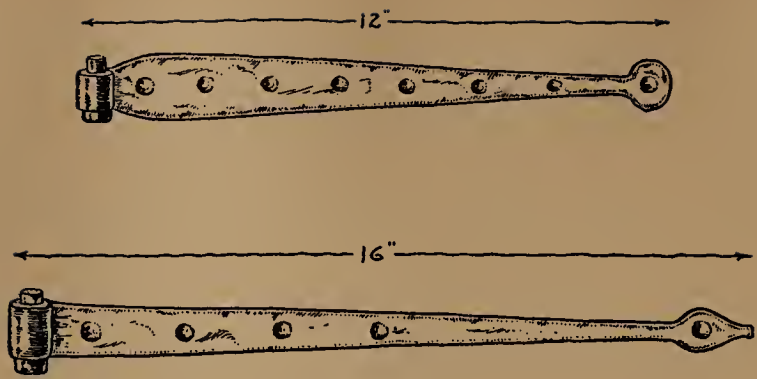
FIGURE 212.

The earliest types of door hinges are undoubtedly those of strap form, such as are shown in Figure 212. Hinges of this variety are usually very long: specimens measuring

two feet or more in length are not uncommon. The butt end of each hinge was formed into an eye, which was hung upon a shouldered iron peg driven into the door jamb. Strap hinges were used more than any other variety for hanging exterior doors, and their use there persisted until a fairly late date. The "snake" hinge (Figure 213) is a pleasing variation which does not commonly occur in Connecticut. It is plainly an attempt at decorative

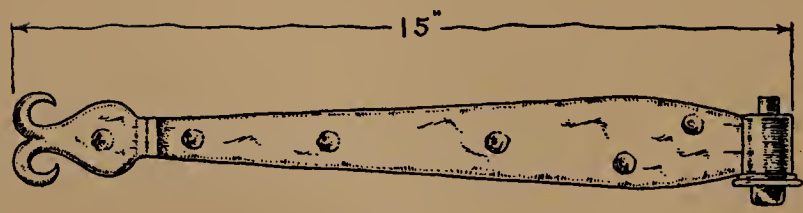
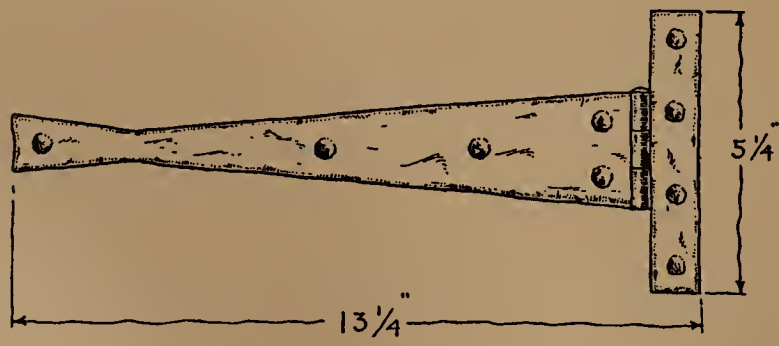
FIGURE 214.

form, and its undulant outline is very pleasing. This specimen was in use on an inside door, as were the two hinges shown in Figure 214. The upper example shown in this illustration is unusual because of its bifurcated termination; that beneath it is noteworthy because it shows a transitional form which developed from the strap hinge. A somewhat similar, though possibly earlier, specimen is shown in Figure 216. A plate of more or less ornamental form has replaced the peg of the earlier type. This hinge is a rare specimen; the writer has seen its like but twice in Connecticut. Three other examples of "half-strap" form are shown in Figure 217. The two lower hinges in the illustration were taken from cupboard

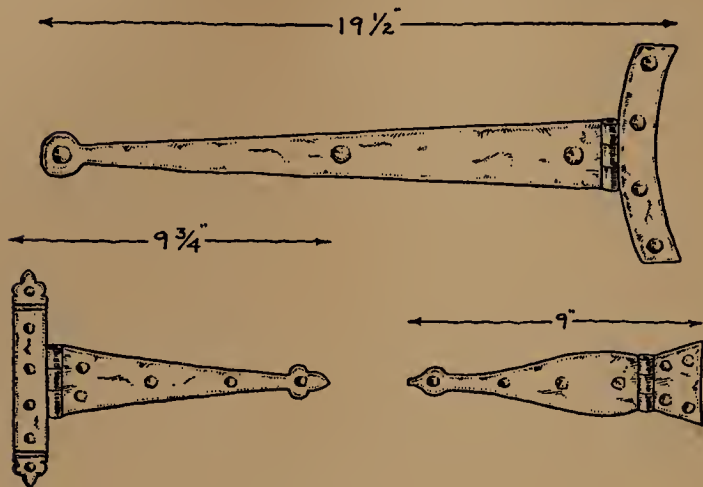
FIGURE 217.

doors; that above them is a regular door hinge. Eventually this strap form disappeared, and a hinge which more resembled the modern "butt" took its place.

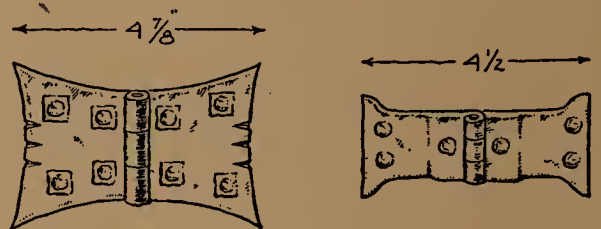
FIGURE 218.

The "butterfly" hinge, shown on the left in Figure 218, is a very old form of English origin. It occurs on chests of English workmanship which date back to the sixteenth century. The hinge shown to the right of it is a later variation. Both were serving on cupboard doors. The three cuts or notches on either outside margin of the butterfly hinge illustrated

are common characteristics; so are the leather washers inserted under the heads of the nails by which it is secured. Red morocco leather was generally used for this purpose; its brilliant color, where it has not been obscured by successive coats of paint, makes it of considerable decorative value. Sometimes leather was also used in this same manner in fastening hinges of earlier type, such as those of strap form. Butterfly hinges were principally used in hanging cupboard doors, though larger forms were sometimes used for regular inside doors as well. The transition is easy from hinges of the butterfly type to specimens which more resemble the modern article, such as those shown in Figure 219. The somewhat fanciful shape and graceful outline have given way to a simple, purely utilitarian form.

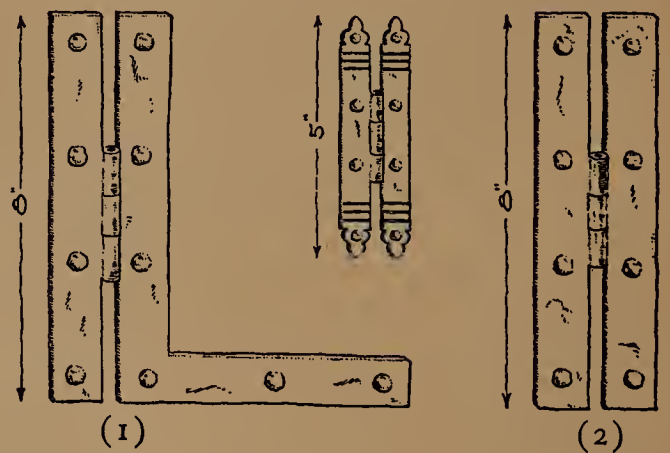
FIGURE 220.

Two familiar forms of hinge, both very commonly used, are shown in Figure 220. They are known as (1) the H-and-L and (2) the H hinge. Not so early as the strap hinge, they were widely used until a very late date; sometimes they occur in work of 1800 or even later. H and H-and-L hinges were used more commonly than any other variety for hanging interior doors; in fact, they appear to have been the conventional forms for this purpose. Their average measurement is about eight or nine inches, though here and there specimens are found of much greater size. Those on the front door of the Captain Ambrose Whittlesey house in Saybrook (1799) are thirteen inches wide and the same in height. H-and-L

hinges are rarely used in this manner for hanging exterior doors: strap hinges were the favorite sort for that purpose. A more decorative form of the H hinge is also shown in Figure 220. Hinges of this sort, of three lobed termination and cross scored, were generally used for inside shutters and cupboard doors.

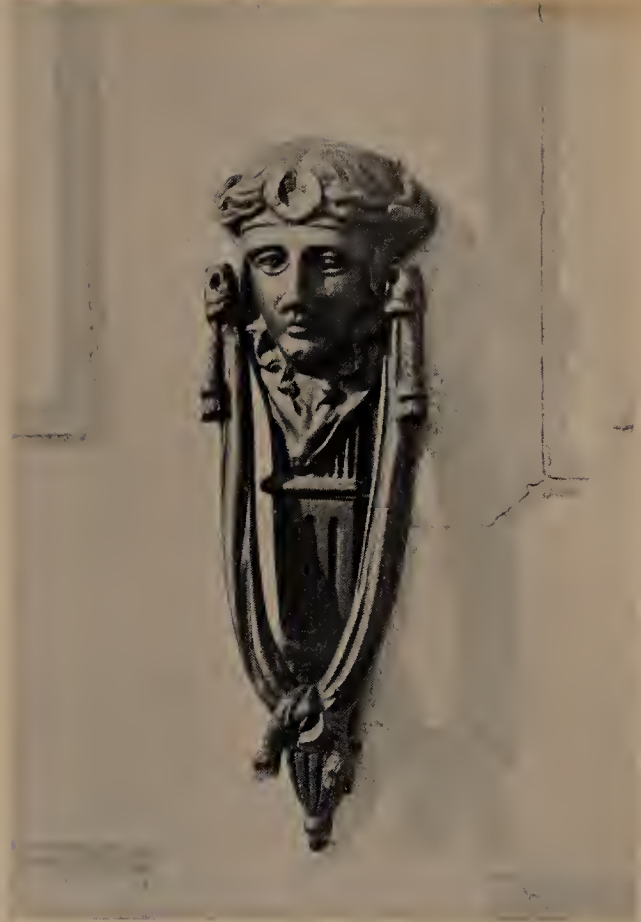
BRONZE KNOCKER—CHESTER

Silliman house near Fairfield (*circa* 1730), is undoubtedly of very early workmanship: possibly it is of English make. The knocker illustrated in Plate XLVIII from the Warner house near Chester (1793) is an unusually fine specimen. It is made of cast bronze, and beautifully finished. A cast-iron knocker from the so-called Historical House in Norwalk (*circa* 1750) is also shown in Plate XLVIII. Most door knockers, however, were of cast brass, polished and buffed to a high finish. It is probable that they were largely produced in England and imported to this country. Cast-iron specimens such as that shown in Plate

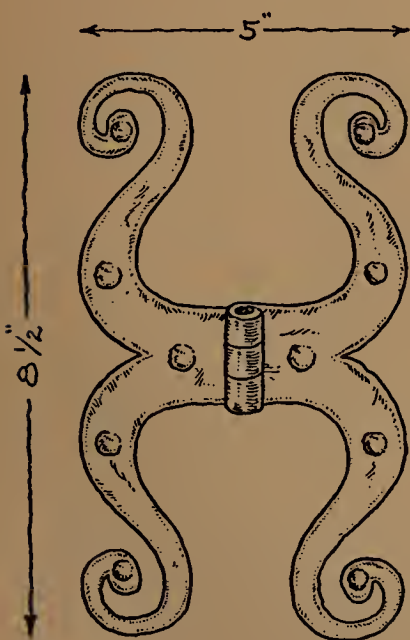
FIGURE 222.

The hinge shown in Figure 222 is an extremely rare and unusually elaborate form. When discovered, it was serving as a barn door hinge; but it is not probable that it was originally wrought for such a purpose. An equally rare specimen is that illustrated in Figure 223. Its decorative form reaches far back into antiquity, the "cock's head" terminations which it displays being a traditional heritage from Roman times. In the house from which this hinge was taken, similar specimens were serving on wall and corner cupboard doors.

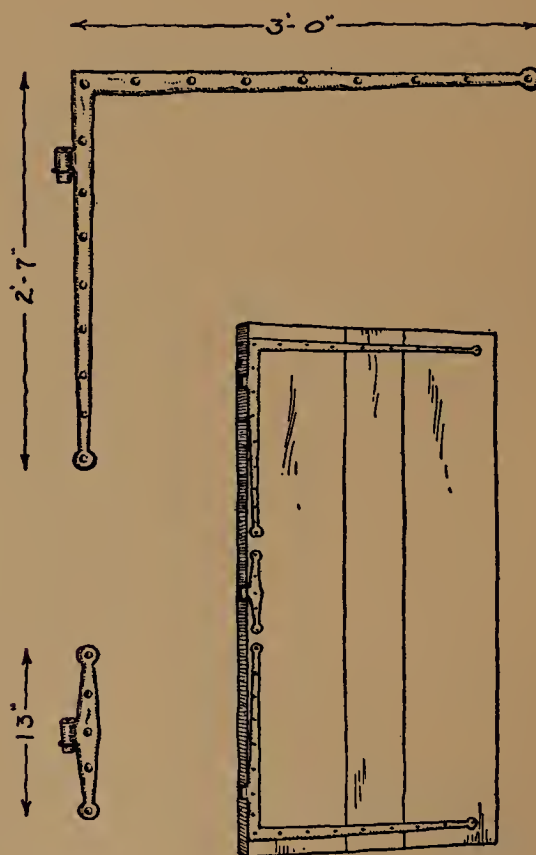
FIGURE 224.

The set of exterior door hinges from the Deming house in Colchester (1771), illustrated in Figure 224, are splendid specimens. They have not only an ornamental value, but a structural one as well, for their great size and peculiar shape make the door much more rigid and add to its strength.

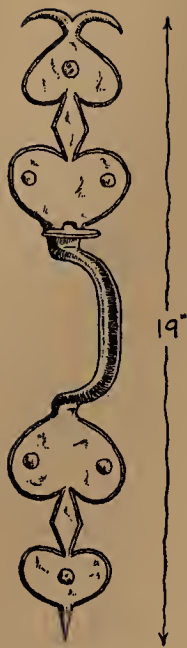
• HADLYME FERRY •  
FIGURE 226.

A great proportion of such latch handles, especially those of an early period, designed for use on outside doors, were of comparatively large size. Those shown in Figures 226 and 227 are early forms; both are bold and vigorous in design. Notches, or V-shaped incisions in the handle, such as the specimen shows in Figure 228, are a common feature. In some instances an attempt at ornamentation was made by scoring the handles with horizontal cuts from a chisel or other edged tool. The iron latch shown in Figure 229, from an outside door of the Chaffee house in Windsor, bears the date of building of the house (1776), pricked into the handle. What is perhaps the most typical form of iron latch handle to be found in Connecticut is that illustrated in Figure 230. The use of square bits of red Morocco leather under the nail heads is characteristic.

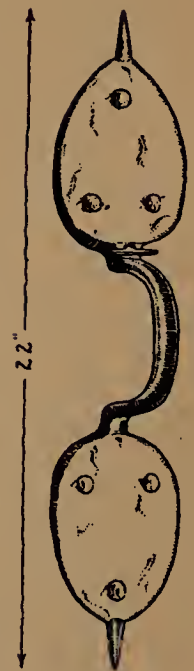
COLCHESTER  
FIGURE 231.

The latch handle shown in Figure 231, though of common form, is extraordinary in size; and for this reason it is a decorative feature of much interest and value. Although

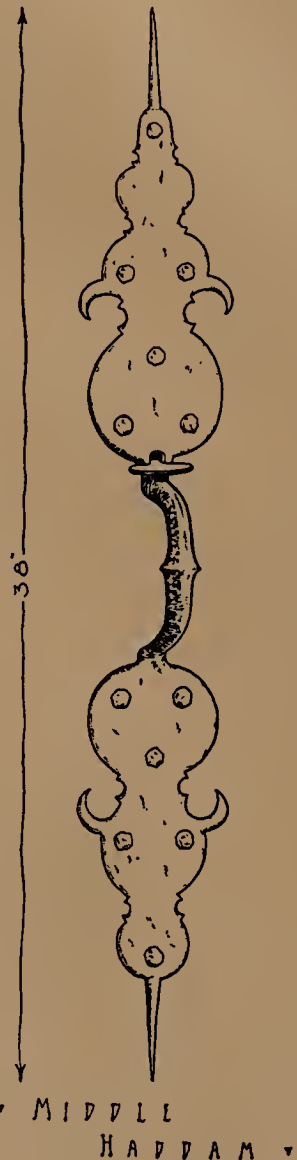
FIGURE 232.

not strictly within the confines of domestic architecture, a wrought-iron latch handle from the church door at Middle Haddam, one of unusual size and exceedingly handsome form, is illustrated in Figure 232.

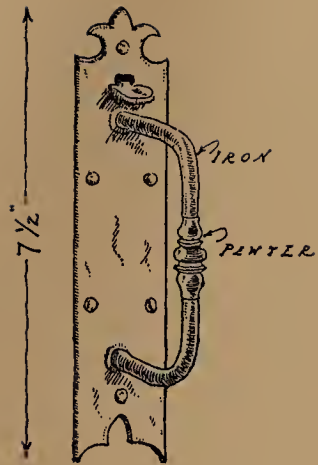
FIGURE 233.

Specimens such as those shown in Figure 233, though they represent a very common type, belong to a much later period. They are of much smaller size than those earlier in use; and being, apparently, "shop made," they are of considerably less interest than the foregoing examples, which were all hand-wrought. The little fillet of pewter applied to the handle is a characteristic feature of latches of this type. The use of small-headed nails in place of the hand-forged variety with large flat heads detracts considerably from the general interest and decorative value of these latches of later type.

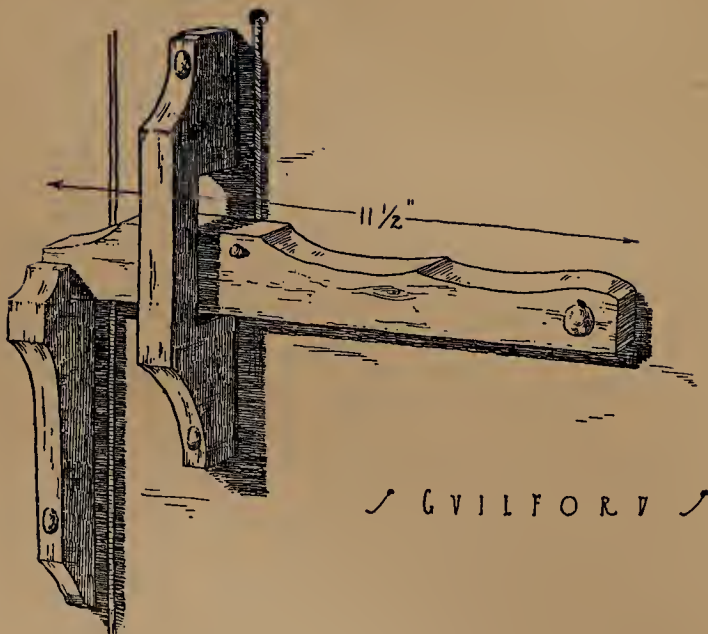
FIGURE 235.

It is quite probable that, during the earliest period of the colony, wooden latches, such as the one shown in Figure 235, were in common use, especially on doors in the less important parts of the house—*e.g.*, those of the rear rooms and those on the second floor. The latch from which the illustration was made was on a door opening from the kitchen chamber of the Caleb Dudley house in Guilford, built about 1690, and is doubtlessly as old as the house itself. A somewhat similar latch of wood secures a door of one of the rear rooms on the second floor of the Graves house in Madison (1675). Latches of this sort possess that oft-quoted feature, the latch-string.

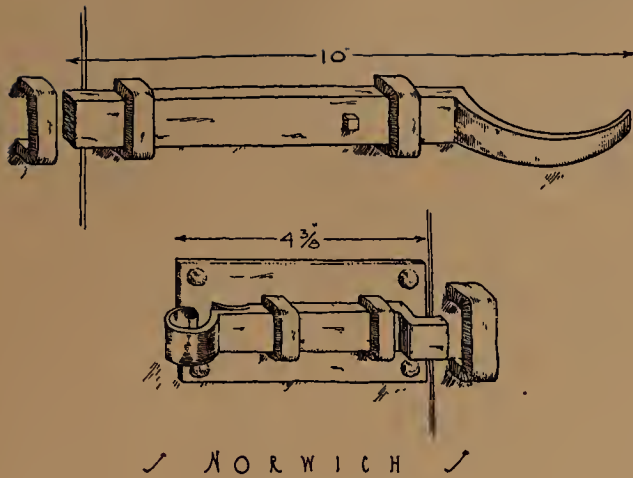
FIGURE 237.

In addition to the arrangement of a horizontal wooden bar across the inner side of an exterior door, various forms of wrought-iron bolts were common means of outside door fastening. Two typical specimens are shown in Figure 237. Locks did not come into general use until after Revolutionary times. Early examples are very often fitted with clumsy wooden casings, such as that illustrated in Figure 238. The working parts, of course, are of metal.

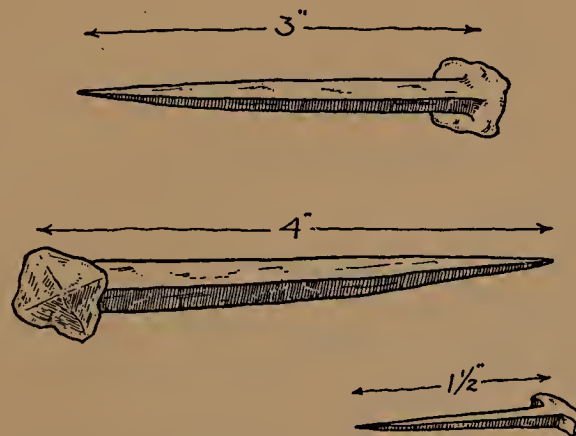
FIGURE 239.

Several specimens of hand-forged nails are shown in Figure 239. Their use covers a wide period, from very early until—in some parts of Connecticut—after 1800. Wrought-iron nails were used in every part of the house construction except in fastening together the oak framework, for which purpose, of course, oaken pegs were used. The smallest nail shown in the illustration is of the sort used in finishing interior woodwork, especially mouldings. Its peculiar shape was such that it could be driven into woodwork so that its head did not remain exposed. It was accordingly the "finishing-nail" of early days.

Wrought-iron nails were succeeded in use by machine-made "cut nails," probably because of their comparative cheapness, which was in turn due to greater ease of production. Not only were they inferior in strength and lasting qualities to the hand-forged variety, but they lacked the large flattened heads of the earlier sort. A decorative feature of considerable value was accordingly lost with the passing of the hand-wrought nail. A house

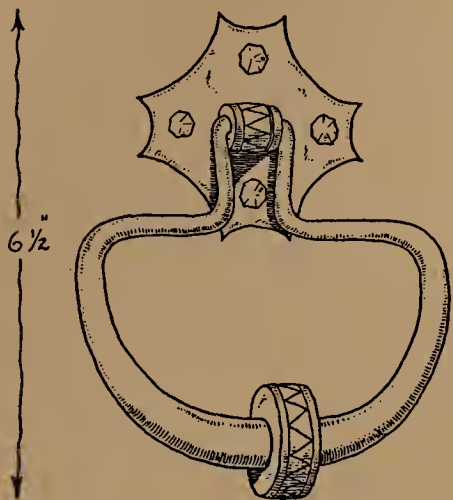
FIGURE 240.

The great majority of the various forms of knockers which adorn the front entrance doors of so many old houses do not date back so far as the houses themselves. As most of them exhibit strong Adam influence, they are necessarily of comparatively late workmanship. Knockers were not employed on the doors of the earliest houses; knuckles served instead. The wrought-iron knocker shown in Figure 240, from the front door of the older

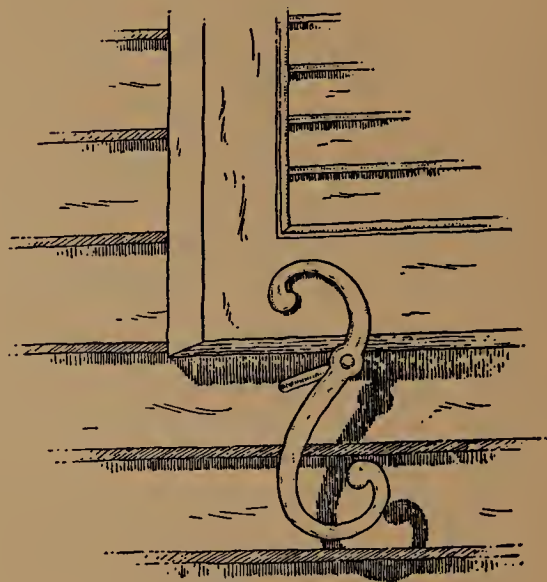
FIGURE 241.

Blind catches of familiar form, constructed of wrought iron, must also be included in a discussion of hardware. A typical specimen is illustrated in Figure 241. Since the blind was a late feature, these fastenings were also of late date.
